Keeping the Conwy Valley connected

The Conwy Valley Line (ELR LTJ1)

The Event

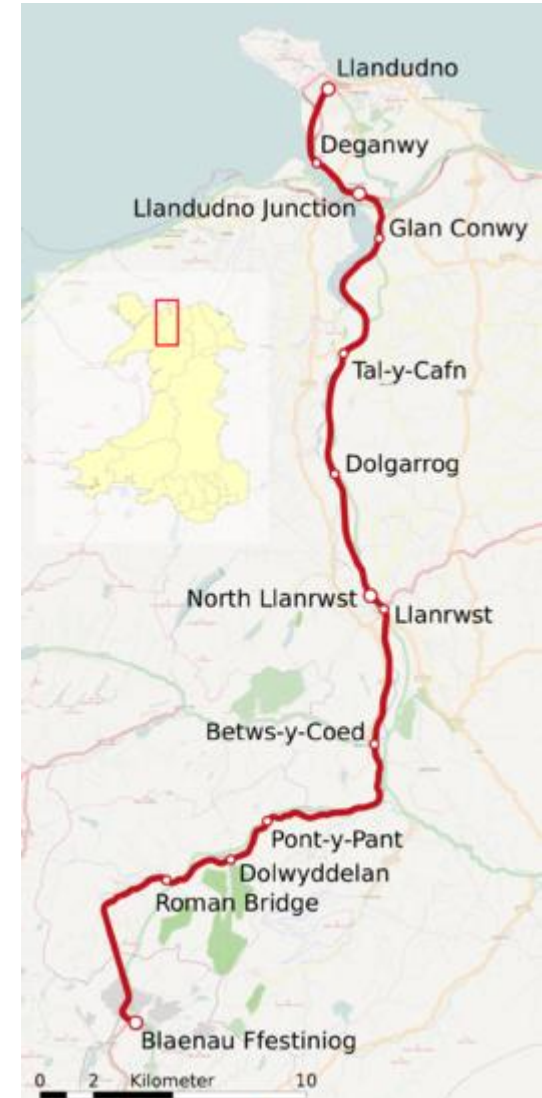
129.8mm rain in Capel Curig in 24-hour period

6.0m Spring high-tide
(reaching 8.2m the following week)

Saturated ground from Storm Gareth, then Storm Hannah

Low lying position of Llanrwst and river catchment

1 in 150 year event

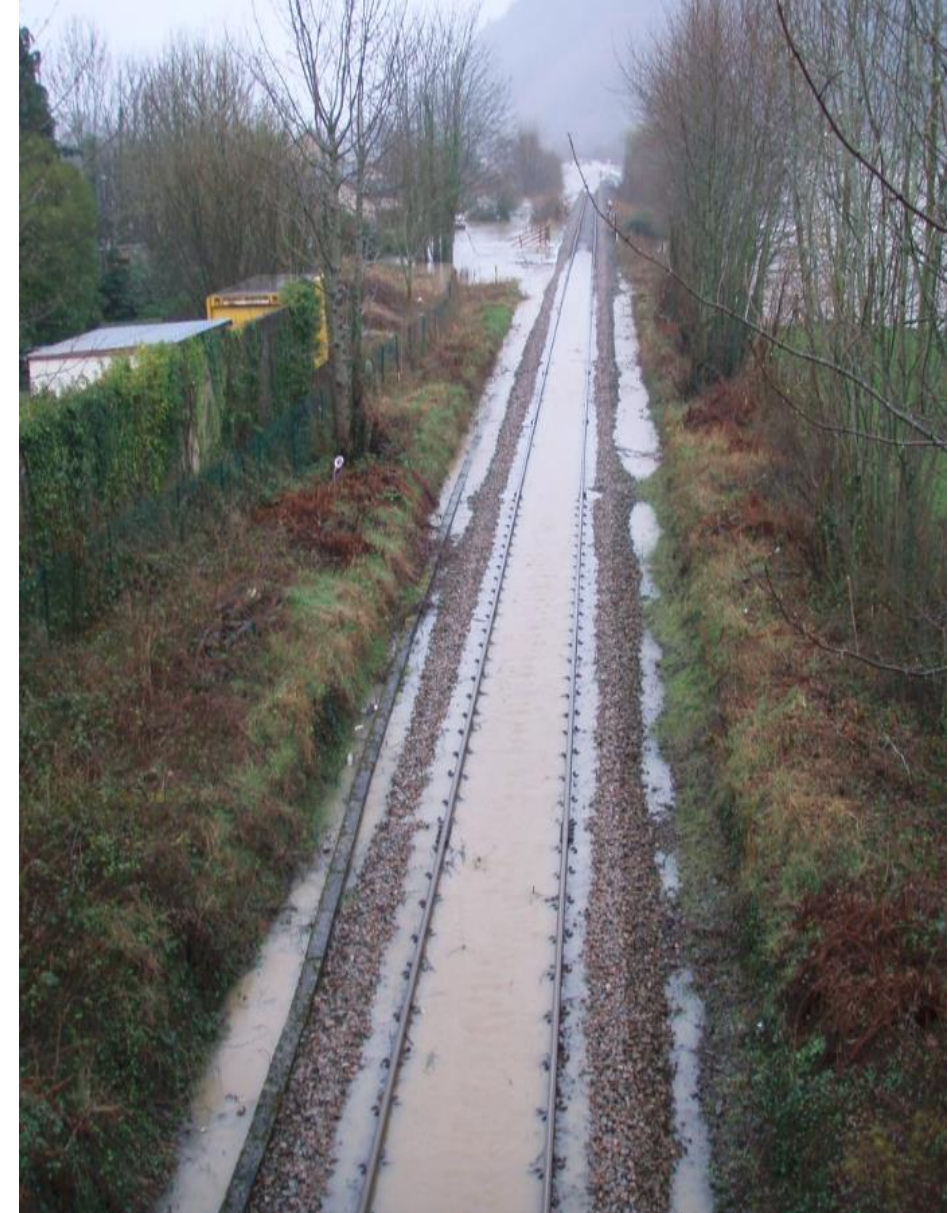
- The Site runs from 05m to 14m and the line was designated a highstreet environment to allow for safer and more efficient working.
- The site was split into 4 areas with differing design issues and solutions.

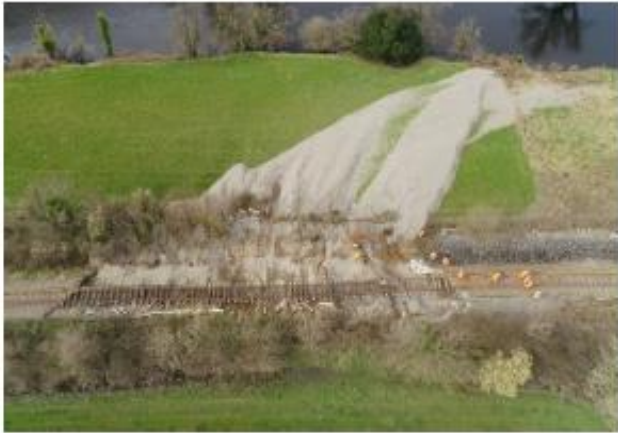
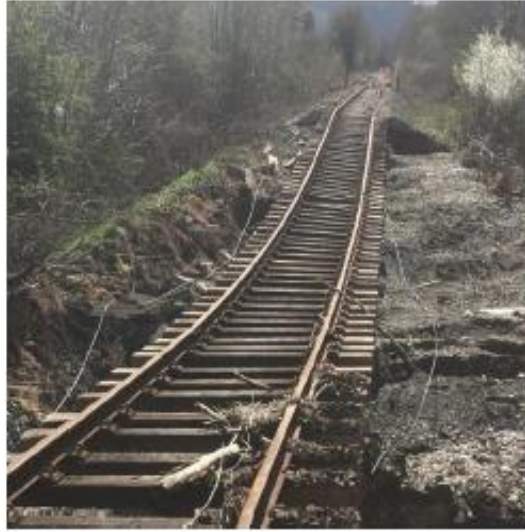
Site A Major washouts 400m of embankment and track renewal.

Site A – The track was required to be removed and the embankment dug out to formation level and re-formed followed by the addition of rock armour to the embankments.

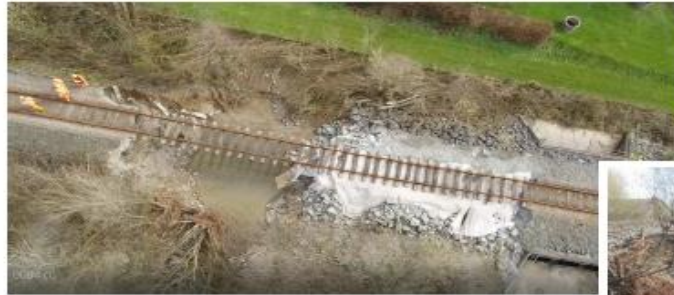
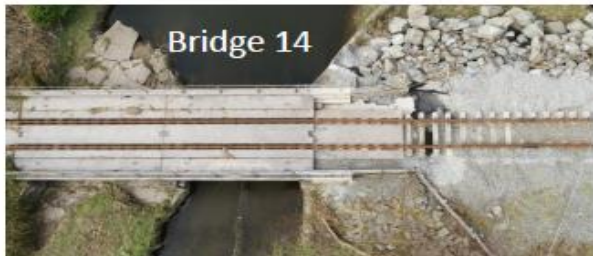
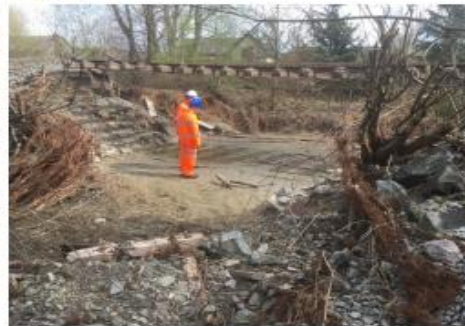
Site B Major washout at 12m 185yds – new culvert to be installed and Bridge 14 works

Site B – Site of the largest wash out - following discussions with NRW a 6 pipe culvert was designed for installation here.

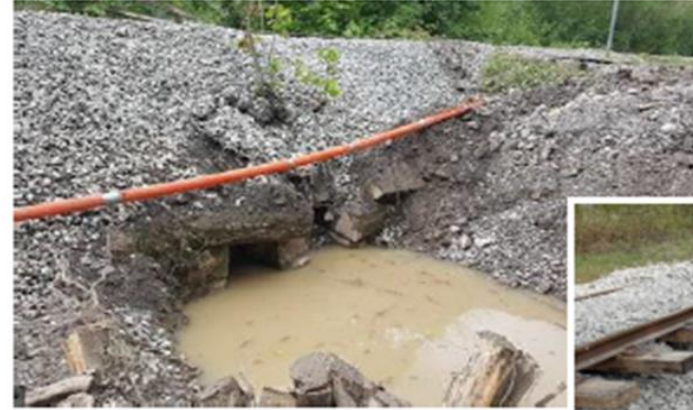
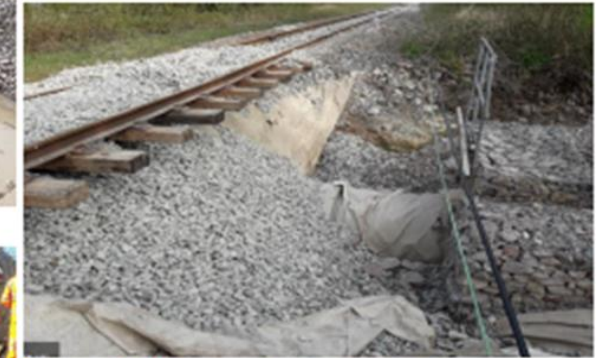
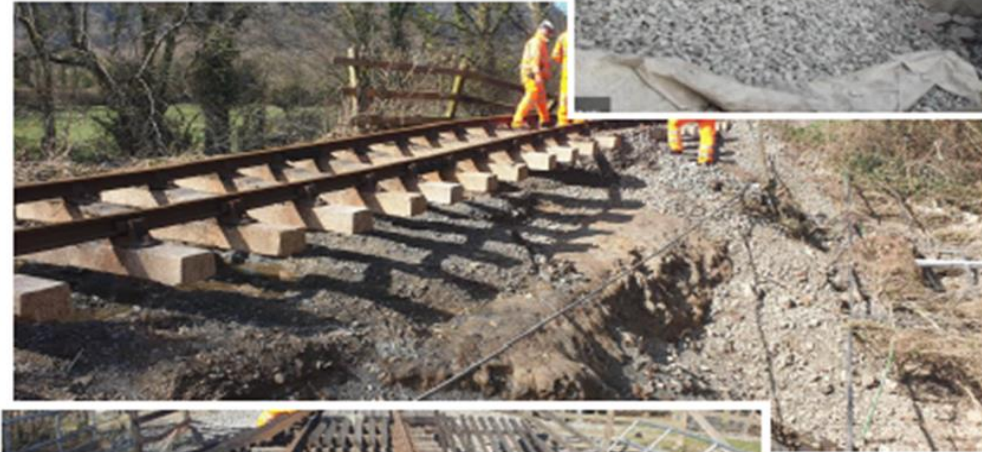
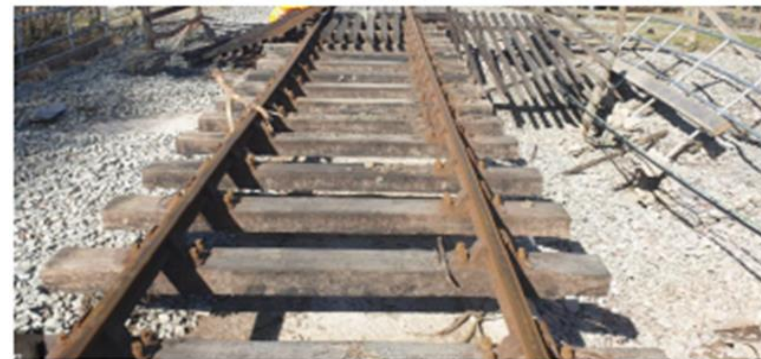
Sites C & D Minor washouts and culvert repairs

Site C – This section has 10 culverts running under the track, two had collapsed and 8 required cleaning out. The two which collapsed were required to be re-lined and re-built. Repairs and gabion baskets were added to the outlets to provide stability in future events.

Site D – This section had ditching which was full of ballast wash out and small track ballast washouts.

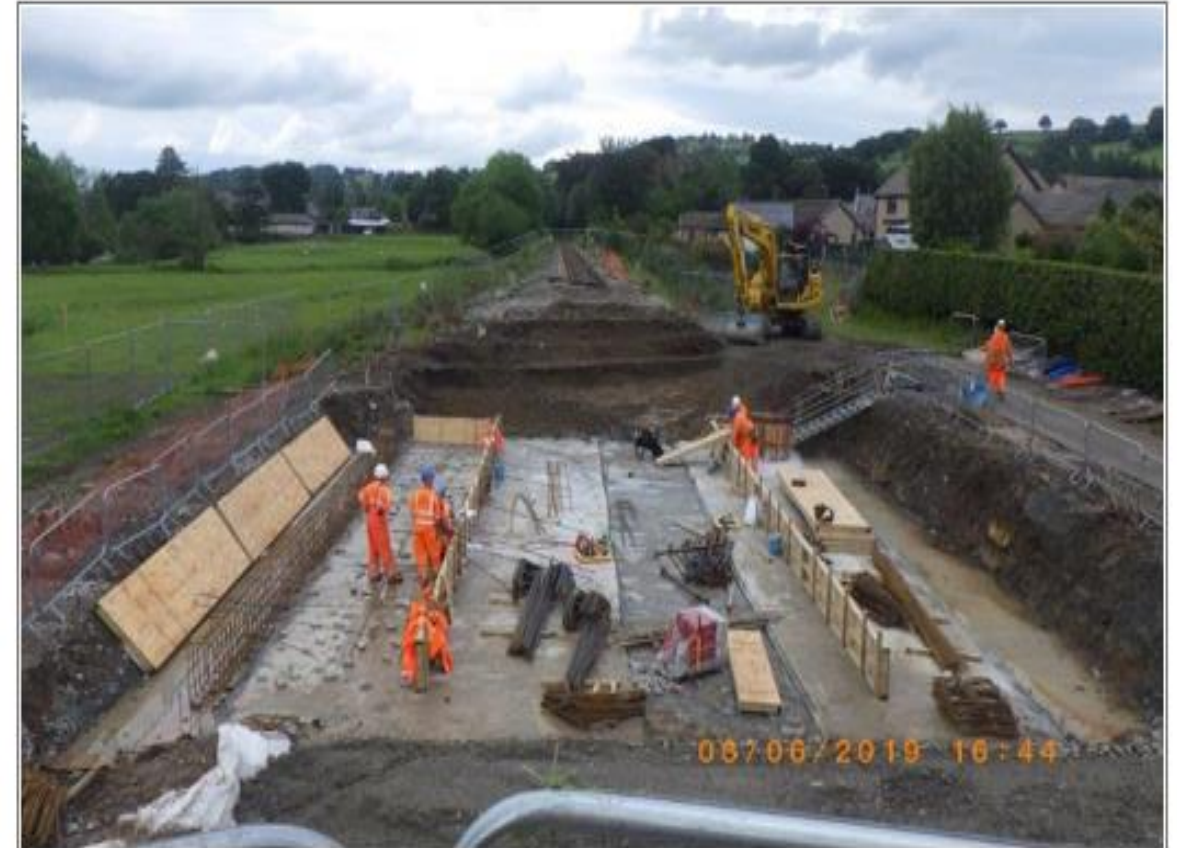
Rebar and shuttering, site B

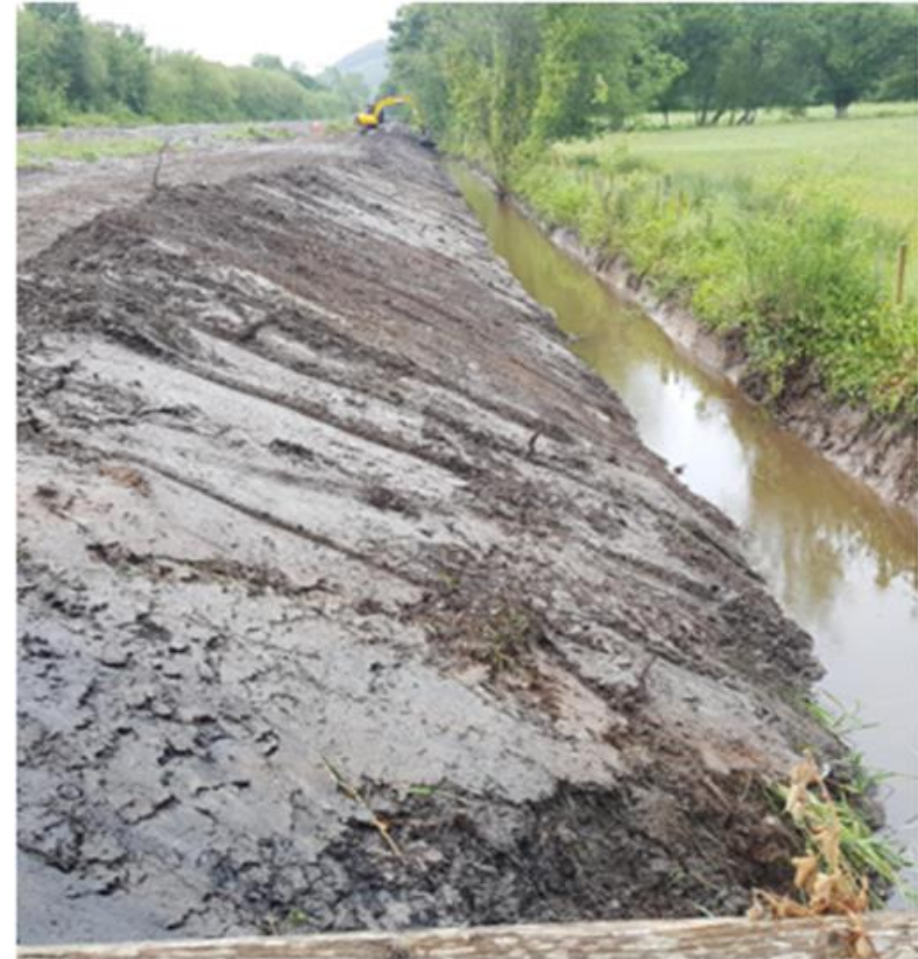
Low mileage ditching works

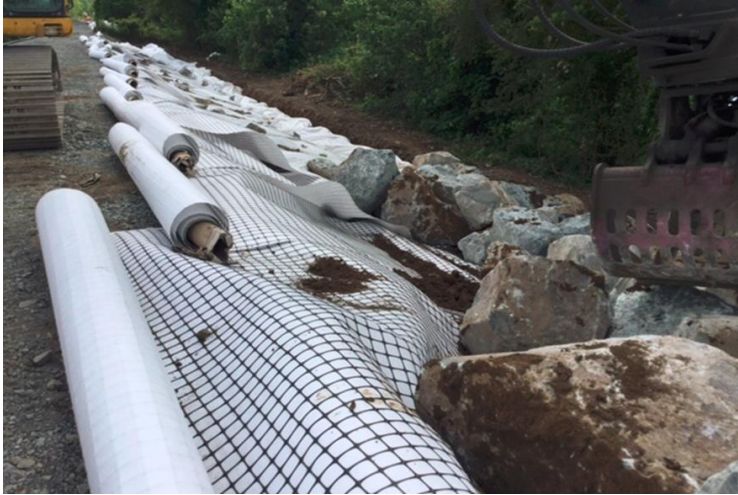
GeoGrid has been added to the embankment rebuilds at site A & B to add friction to the rip-rap installed at these locations should there be a future event this will add resilience.

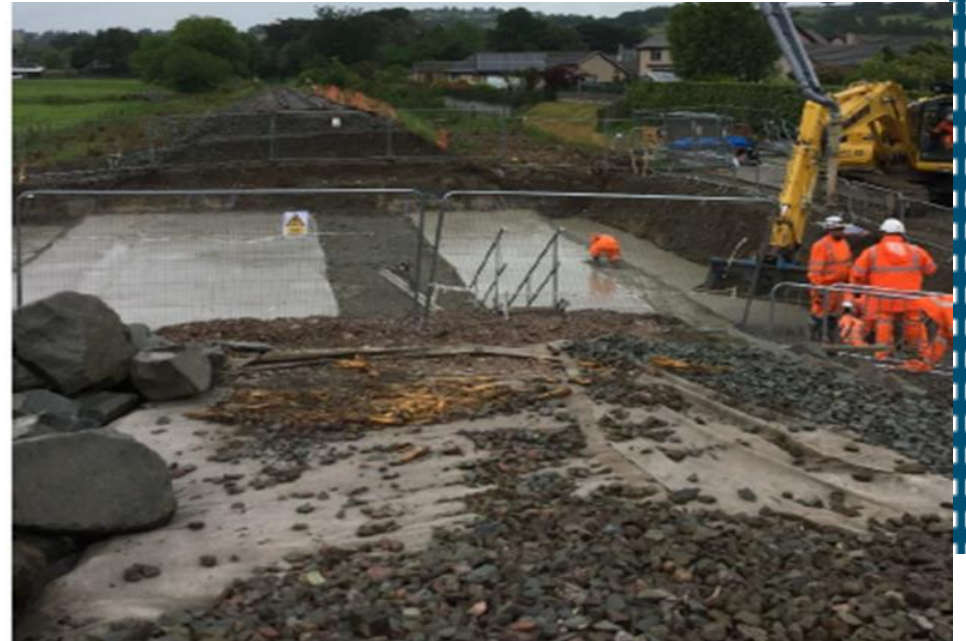
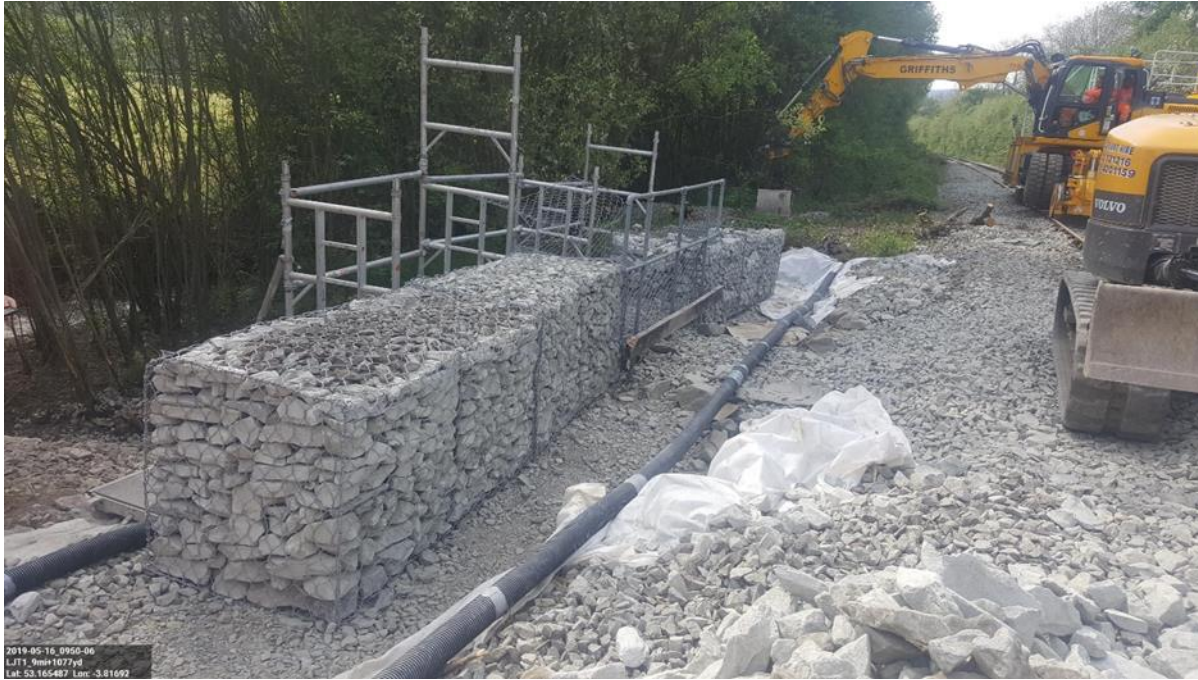
Rock armour at a 45 degree angle has been added to the embankments at Sites A & B to ensure resilience during future flood events, where this was installed in 2015 events the embankment has survived in these locations
